Sent: Thur 6/12/2014 9:34:21 PM Subject: FW: Pix of the Gold King

Subject: Pix of the Gold King

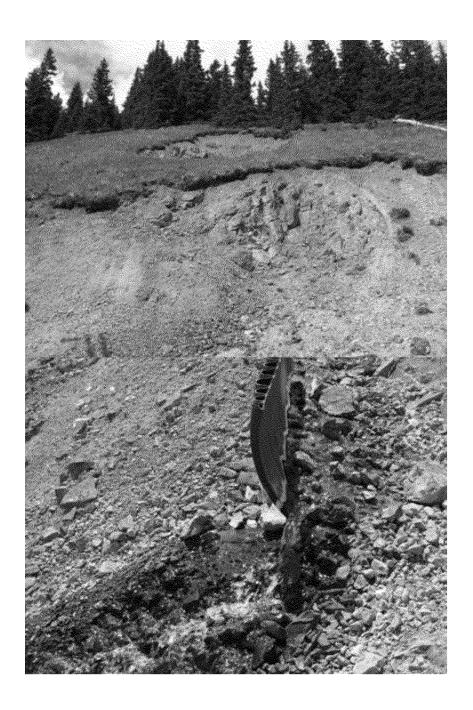
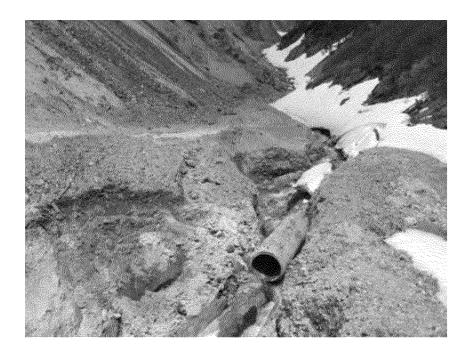
Here are a couple shots from Wednesday at the Gold King mine. The significance of the rock face view is the shallow nature of the overburden before encountering fractured rock. The estimate from Bruce was 25 feet of colluvium. Also, the flow is exceptionally low from the adit whereas normally it is about $50-100~{\rm gpm}$ in this time of year.

Also, the only information available on the tunnel dimensions suggests it may be an 8×8 opening with flat roof/back.
